SPRINGVILLE DAM

**ERIE COUNTY, NEW YORK
INVENTORY No. N.Y. 704**

PHASE I INSPECTION REPORT NATIONAL DAM SAFETY PROGRAM

AUGUST 1981

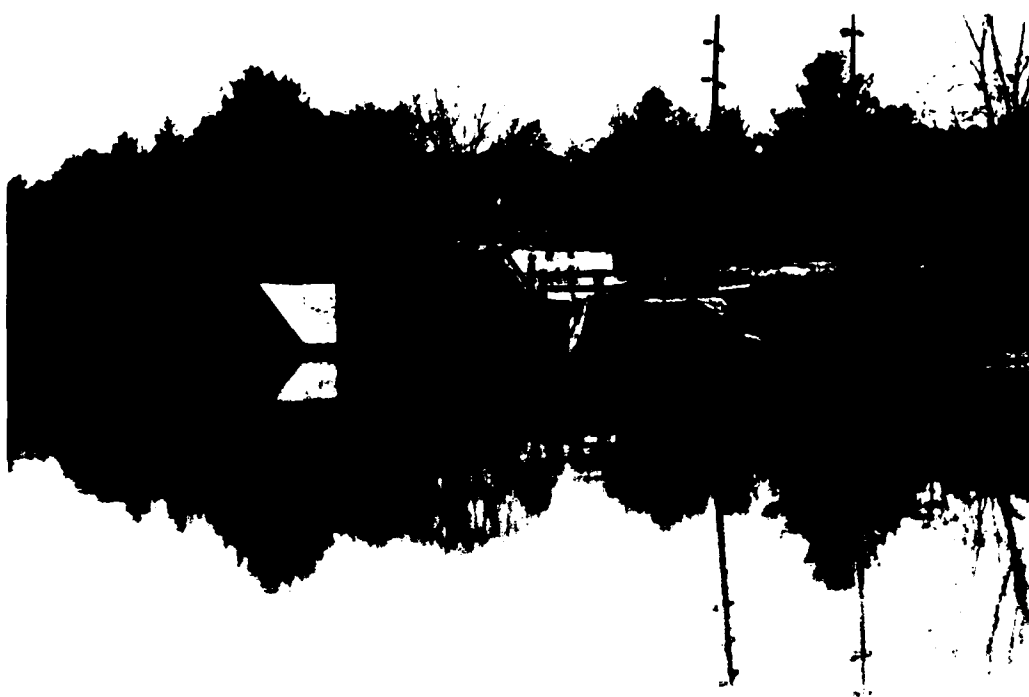
n. Intake Structures Forebay has many surface cracks but is well maintained

9. Powerhouse intake structure
